# ANNUAL REPORT FOR 2008

**Unnamed Tributary to Little Jacob  
Swamp Mitigation Site  
Robeson County  
TIP No. R-0513WM**

Prepared By:  
Natural Environment Unit & Roadside Environmental Unit  
North Carolina Department of Transportation

October 2008

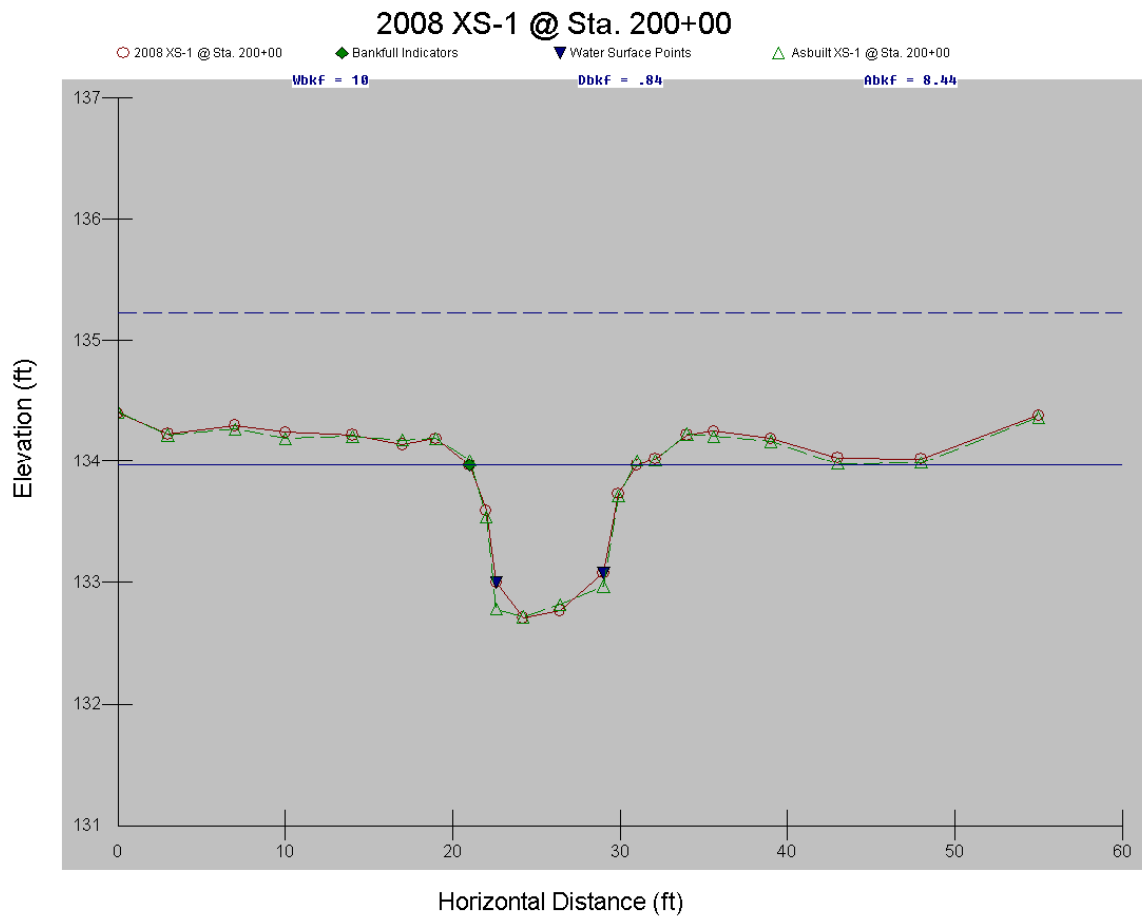
Cross-Section #1 (Riffle) Abbreviated Morphological Summary					
	2008	2009	2010	2011	2012
Bankfull Width (ft)	10.0				
Bankfull Mean Depth (ft)	0.84				
Width/Depth Ratio	11.9				
Bankfull Cross Sectional Area (ft <sup>2</sup> )	8.44				
Maximum Bankfull Depth (ft)	1.26				
Width of the Floodprone Area (ft)	55				
Entrenchment Ratio	5.5

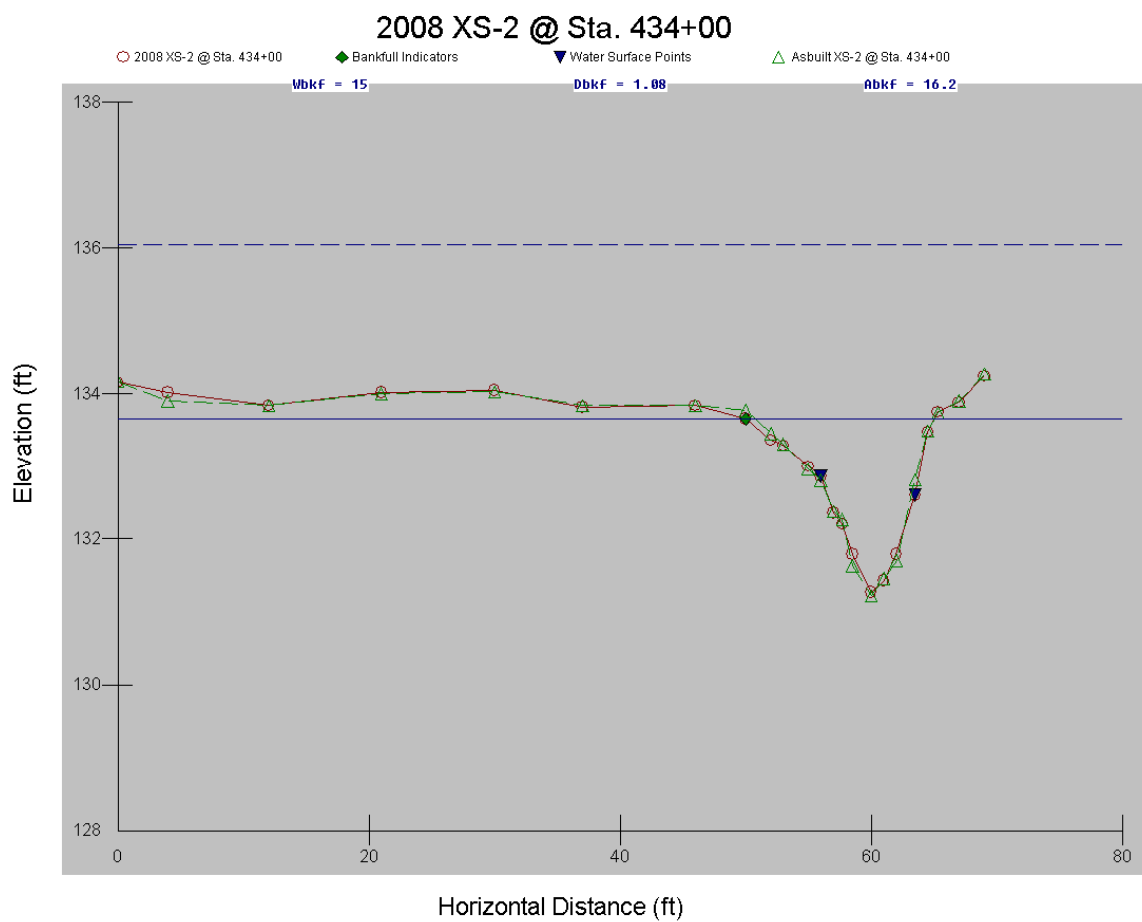
Cross-Section #2 (Pool) Abbreviated Morphological Summary*					
	2008	2009	2010	2011	2012
Bankfull Cross Sectional Area (ft <sup>2</sup> )	16.17				
Maximum Bankfull Depth (ft)	2.39				
Bankfull Mean Depth (ft)	1.08				
Bankfull Width (ft)	15.03

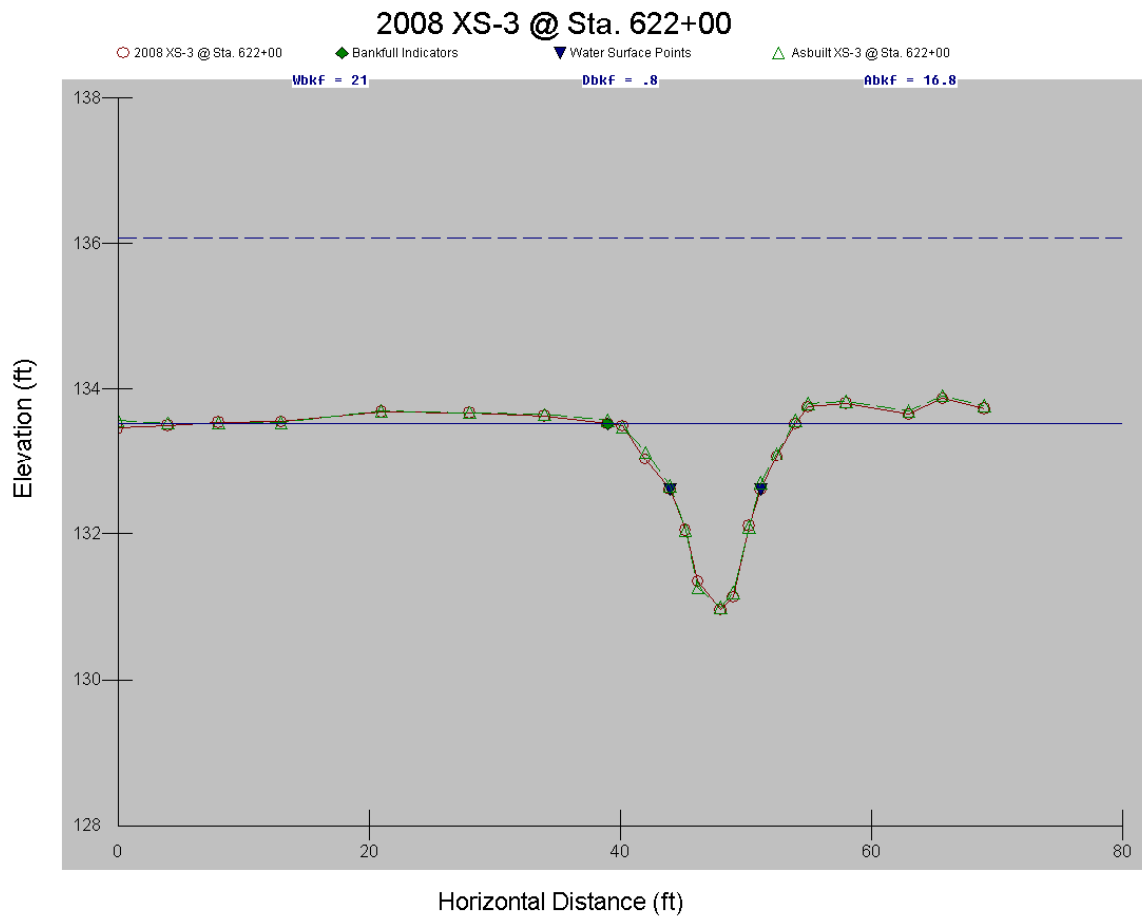
Cross-Section #3 (Pool) Abbreviated Morphological Summary*					
	2008	2009	2010	2011	2012
Bankfull Cross Sectional Area (ft <sup>2</sup> )	16.78				
Maximum Bankfull Depth (ft)	2.56				
Bankfull Mean Depth (ft)	0.8				
Bankfull Width (ft)	21.0

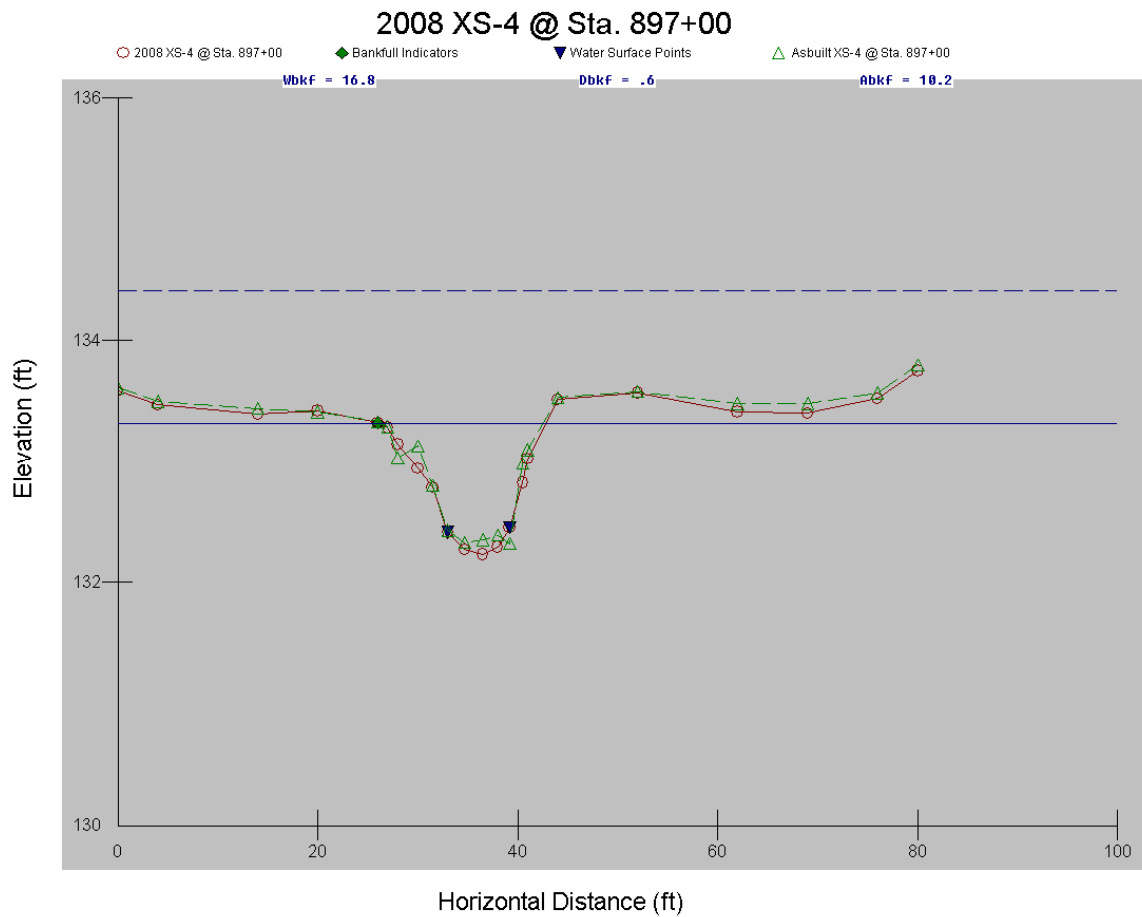
Cross-Section #4 (Riffle) Abbreviated Morphological Summary					
	2008	2009	2010	2011	2012
Bankfull Width (ft)	16.84				
Bankfull Mean Depth (ft)	0.60				
Width/Depth Ratio	28.07				
Bankfull Cross Sectional Area (ft <sup>2</sup> )	10.16				
Maximum Bankfull Depth (ft)	1.09				
Width of the Floodprone Area (ft)	80				
Entrenchment Ratio	4.75

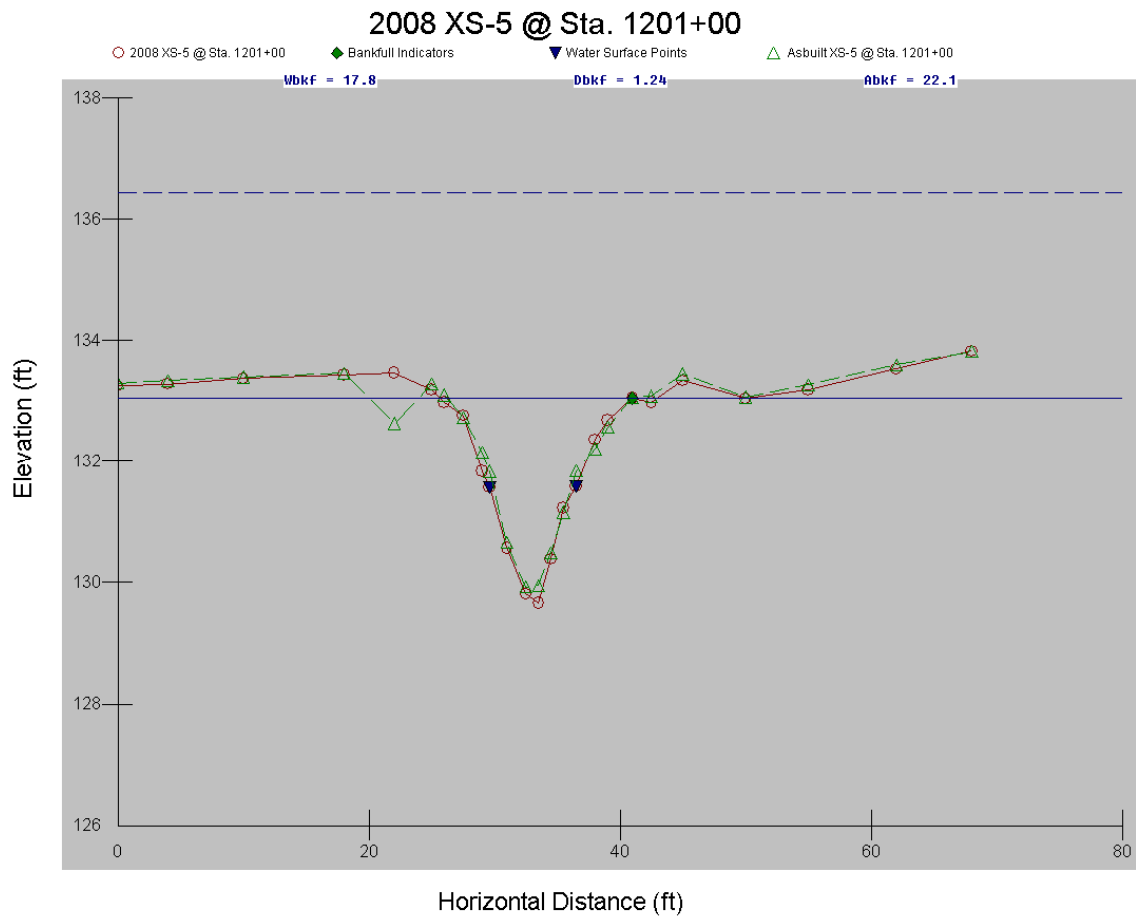
Cross-Section #5 (Pool) Abbreviated Morphological Summary*					
	2008	2009	2010	2011	2012
Bankfull Cross Sectional Area (ft <sup>2</sup> )	22.13				
Maximum Bankfull Depth (ft)	3.39				
Bankfull Mean Depth (ft)	1.24				
Bankfull Width (ft)	8.91

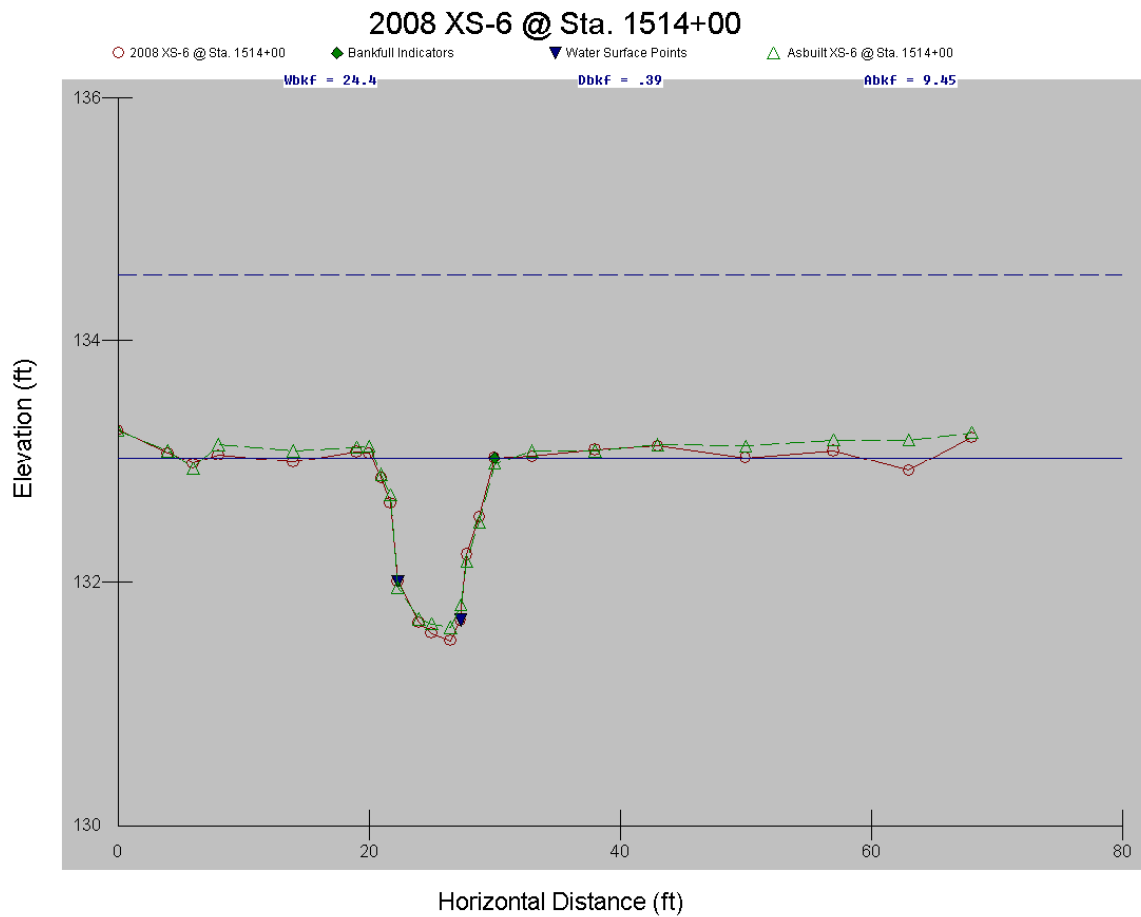
Cross-Section #6 (Riffle) Abbreviated Morphological Summary					
	2008	2009	2010	2011	2012
Bankfull Width (ft)	9.8				
Bankfull Mean Depth (ft)	0.91				
Width/Depth Ratio	10.77				
Bankfull Cross Sectional Area (ft <sup>2</sup> )	8.94				
Maximum Bankfull Depth (ft)	1.51				
Width of the Floodprone Area (ft)	68				
Entrenchment Ratio	6.94

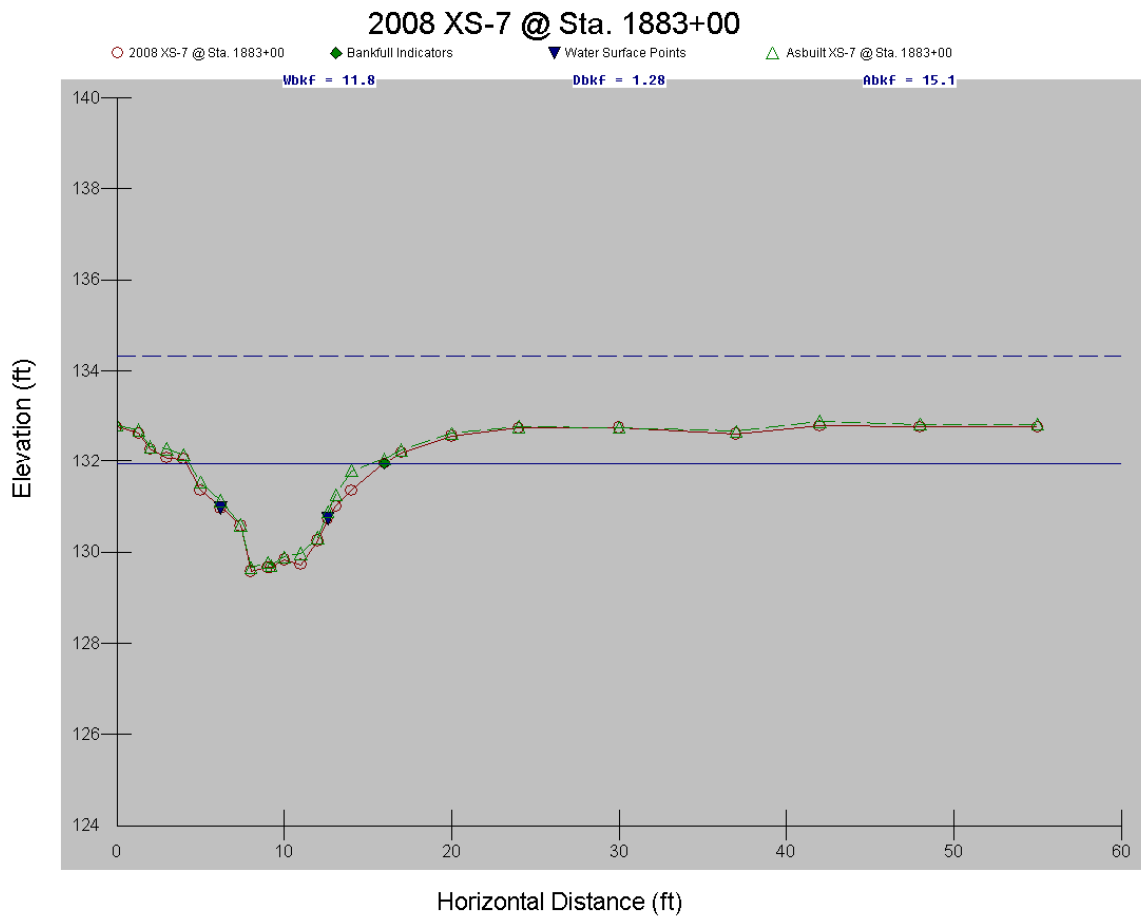
Cross-Section #7 (Pool) Abbreviated Morphological Summary*					
	2008	2009	2010	2011	2012
Bankfull Cross Sectional Area (ft <sup>2</sup> )	15.14				
Maximum Bankfull Depth (ft)	2.37				
Bankfull Mean Depth (ft)	0.80				
Bankfull Width (ft)	11.85

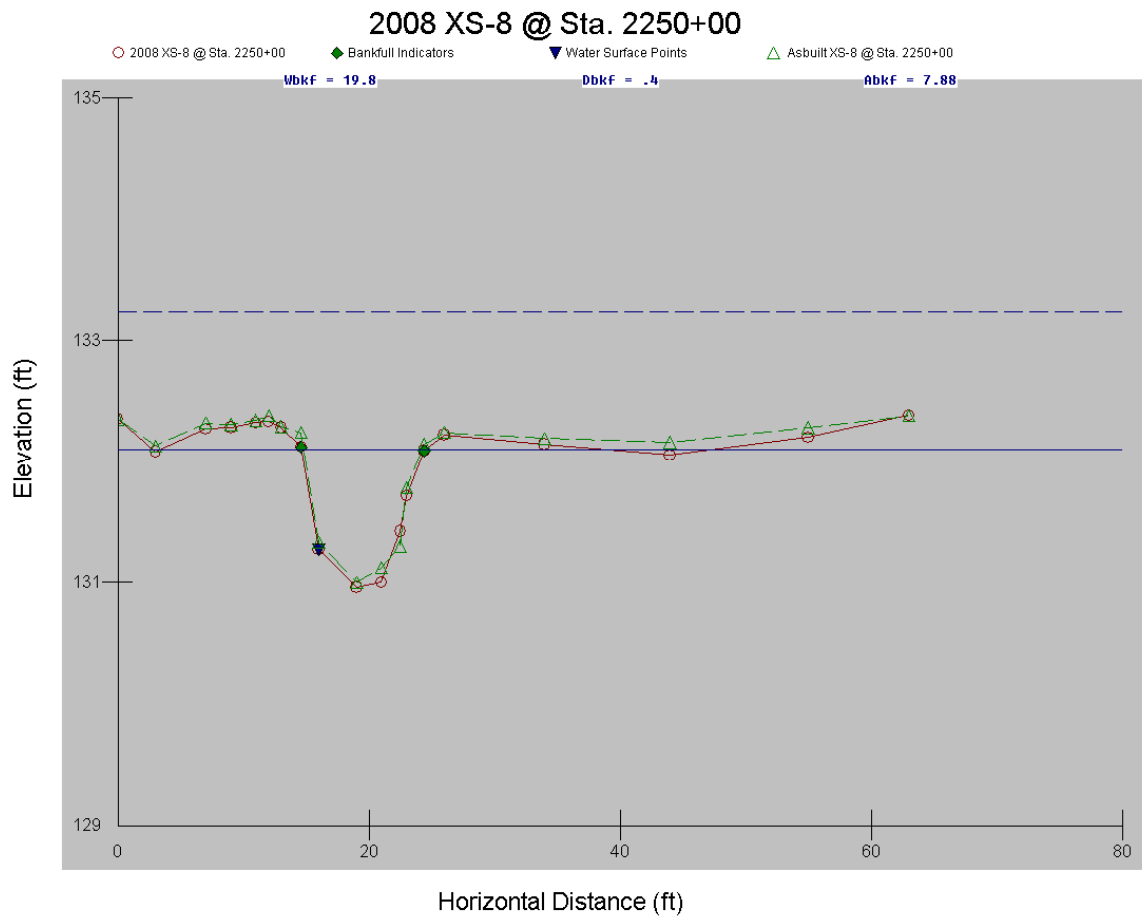
Cross-Section #8 (Riffle) Abbreviated Morphological Summary					
	2008	2009	2010	2011	2012
Bankfull Width (ft)	9.77				
Bankfull Mean Depth (ft)	0.78				
Width/Depth Ratio	12.53				
Bankfull Cross Sectional Area (ft <sup>2</sup> )	7.64				
Maximum Bankfull Depth (ft)	1.14				
Width of the Floodprone Area (ft)	63				
Entrenchment Ratio	6.45

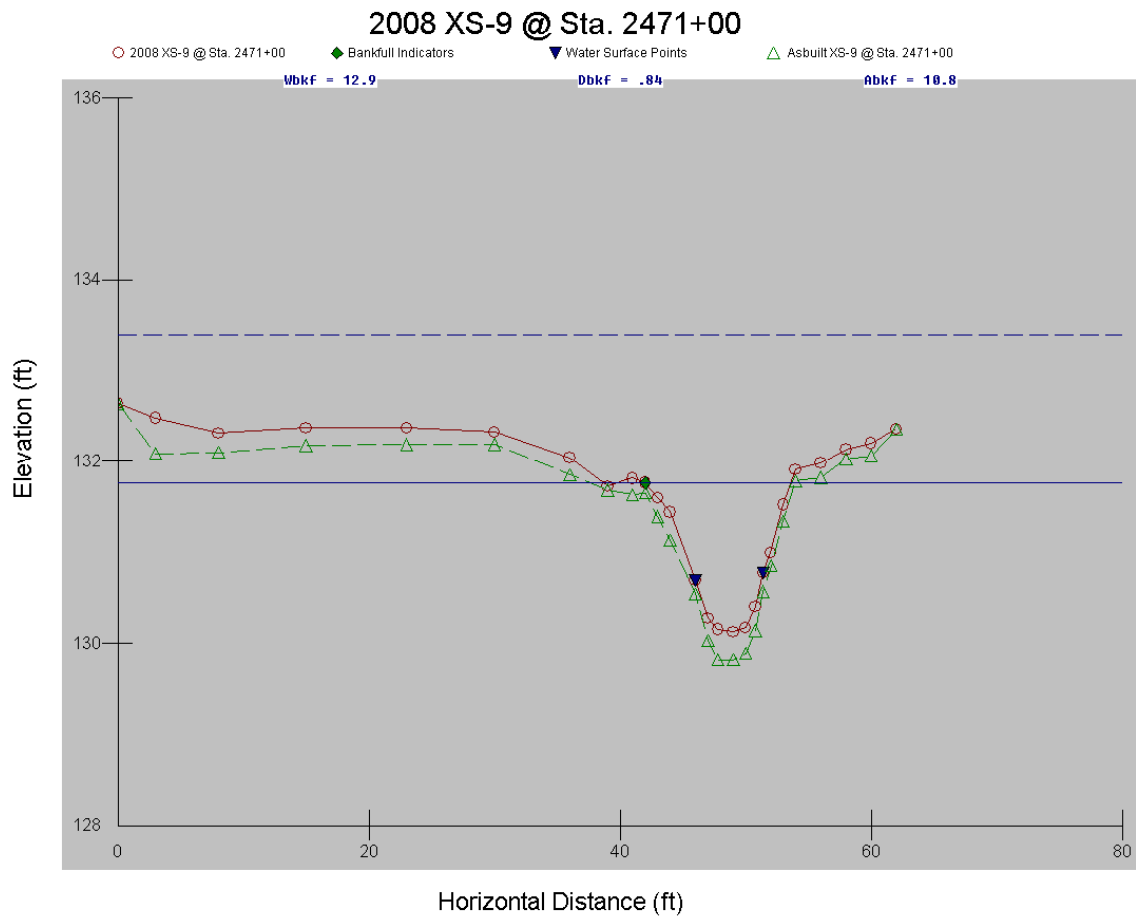
Cross-Section #9 (Pool) Abbreviated Morphological Summary*					
	2008	2009	2010	2011	2012
Bankfull Cross Sectional Area (ft <sup>2</sup> )	10.8				
Maximum Bankfull Depth (ft)	1.64				
Bankfull Mean Depth (ft)	0.93				
Bankfull Width (ft)	11.56

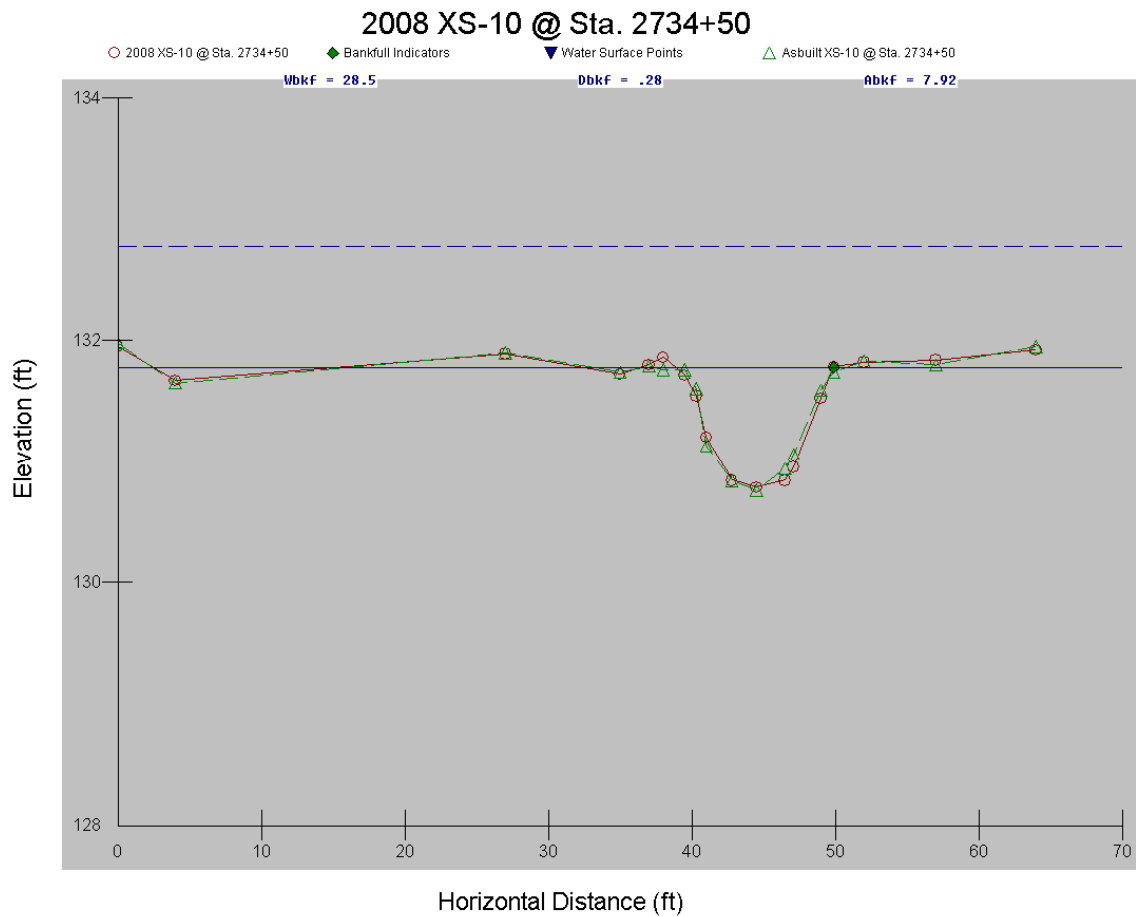
Cross-Section #10 (Riffle) Abbreviated Morphological Summary					
	2008	2009	2010	2011	2012
Bankfull Width (ft)	11.1				
Bankfull Mean Depth (ft)	0.64				
Width/Depth Ratio	17.34				
Bankfull Cross Sectional Area (ft <sup>2</sup> )	7.08				
Maximum Bankfull Depth (ft)	1.0				
Width of the Floodprone Area (ft)	64				
Entrenchment Ratio	5.77

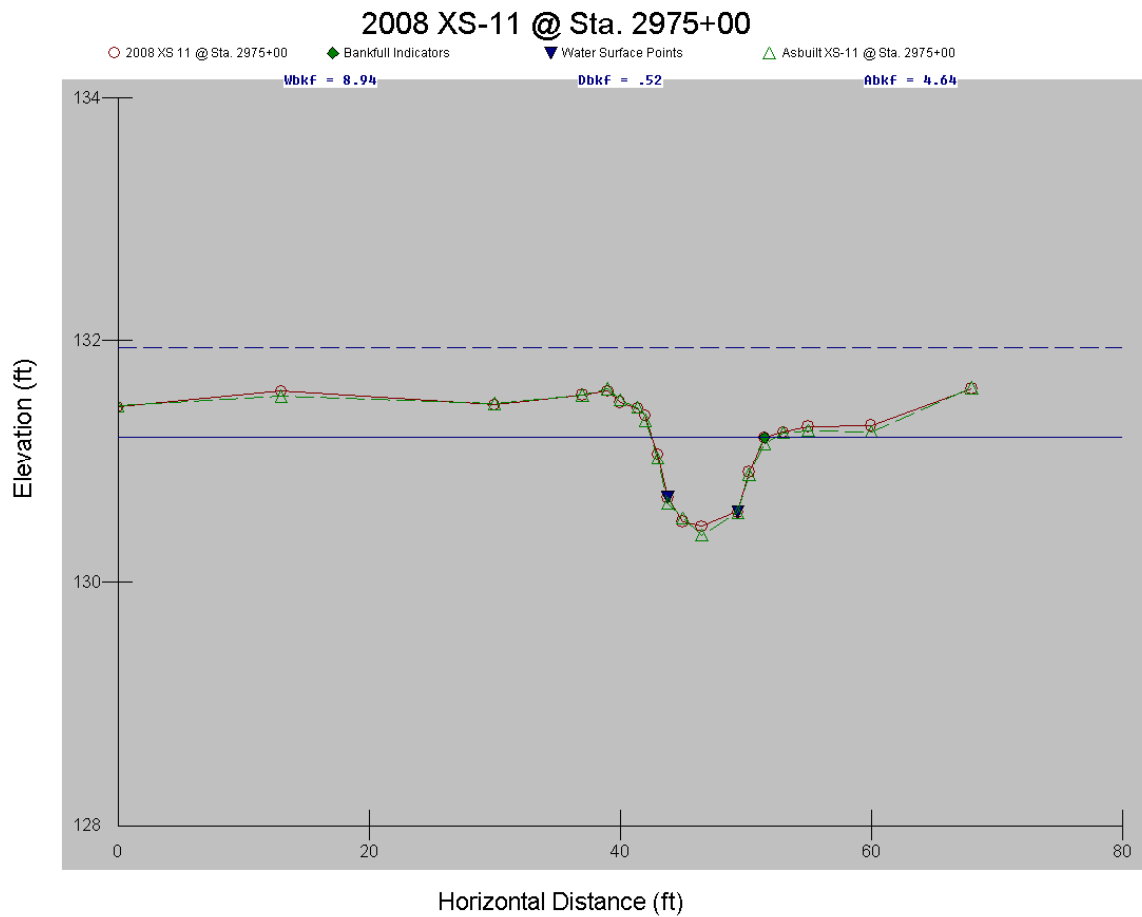
Cross-Section #11 (Rifle) Abbreviated Morphological Summary					
	2008	2009	2010	2011	2012
Bankfull Width (ft)	8.94				
Bankfull Mean Depth (ft)	0.52				
Width/Depth Ratio	17.19				
Bankfull Cross Sectional Area (ft <sup>2</sup> )	4.64				
Maximum Bankfull Depth (ft)	0.74				
Width of the Floodprone Area (ft)	68				
Entrenchment Ratio	7.61
